# Porsche 928 Kick Down Relay XV 1985 and newer – issue: Wrong or failed relay grounds RPM signal

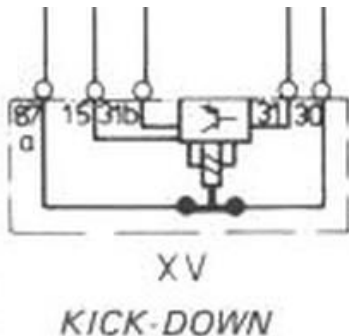
**Issue:** Engine no-start condition, spark but no fuel injection. All other diagnostic checks are OK or inconclusive.

**Potential issue:** Incorrect (standard relay type will not work) or failed kickdown relay in socket grounds out RPM signal to LH fuel injection module. Even an issue for manual-shift 928s if relay is inadvertently installed into relay socket XV (1985 - 1988) or XVII (1989 - 1995)  
**Note correct part numbers listed below.**

**Test:** remove relay from kickdown relay socket position XV, crank engine. If it starts, the kick down relay is the problem.

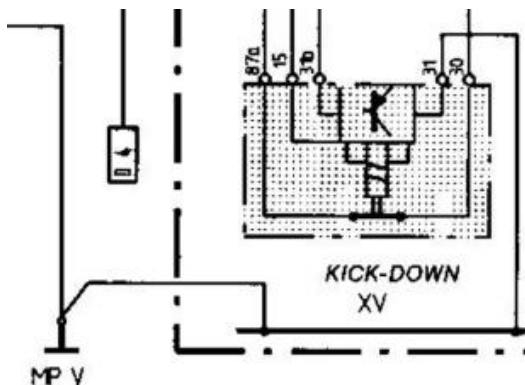
1985 – 1986 928: kick down relay 928.618.109.00  
through 1986 VIN 0998

1986 - : Relay 918.619.109.01 1986 VIN 0999 and  
higher (AKA 1986.5)

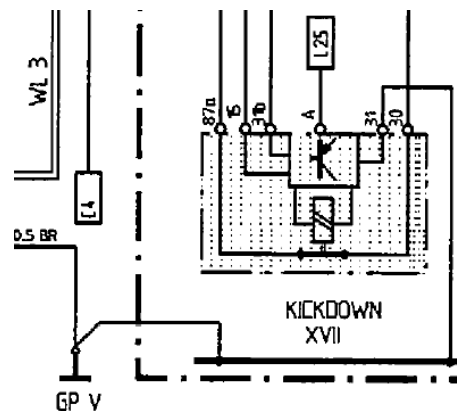
1987 - 1988 relay XV 928.618.109.01  
1989 – relay XV 928.618.108.01  
1990 - 1991 XVII relay 928.618.108.00
